## Arrive Alive – a Tribal Transportation Safety Project funded through the Federal Highways Administration

### 11-23-16 TTSP Initial Implementation Report:\*

#### *“Better Later than Never”*

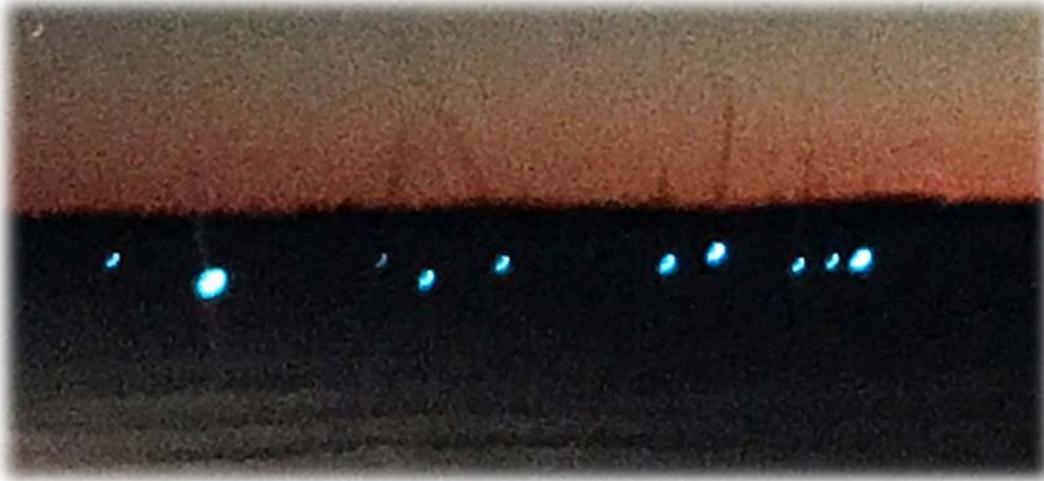
*What Open Water Markers Look Like at Night: BLUE reflectors spaced close together – this is one of the many open holes already marked by Akiachak SAR in their area*

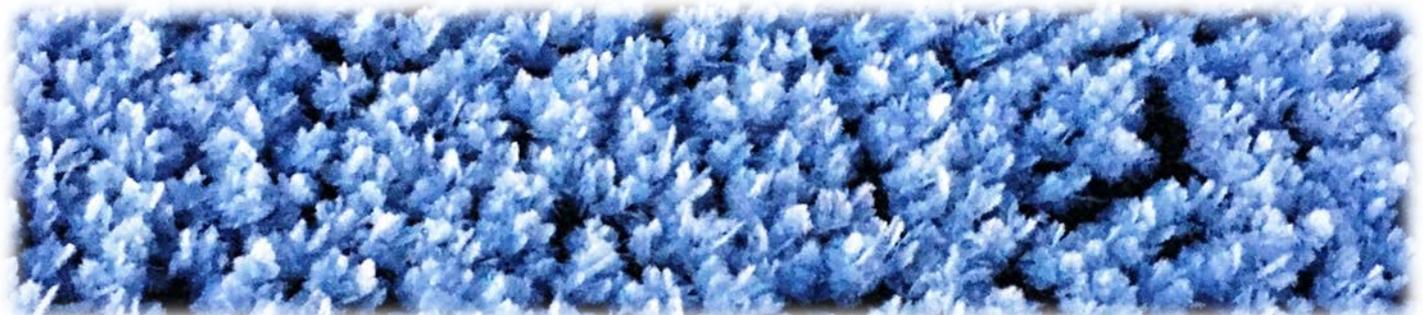
*A Sign of Thin Ice: big flowery ice crystals on top of the ice*

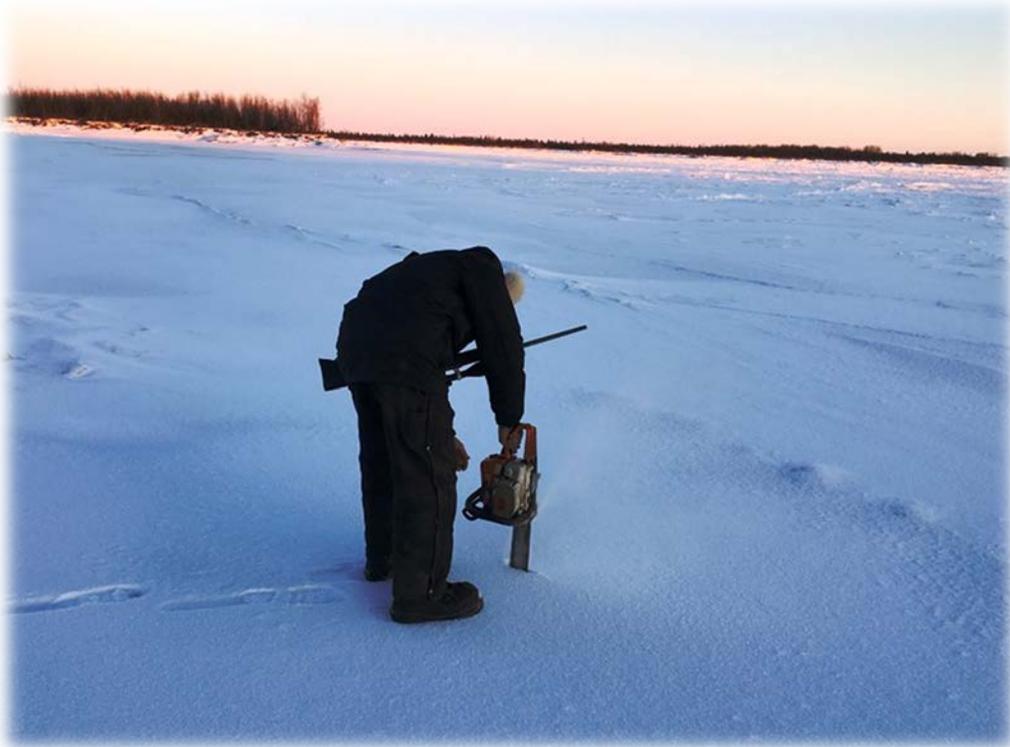
**Ice thickness is still highly variable. Napaimute’s team measured thickness ranging from 4” to 16” during their 130 mile round trip survey. Shell ice was found to be an additional danger to early season travelers.**

*Using a chainsaw with a marked bar to take preliminary measurements of Kuskokwim ice thicknesses*

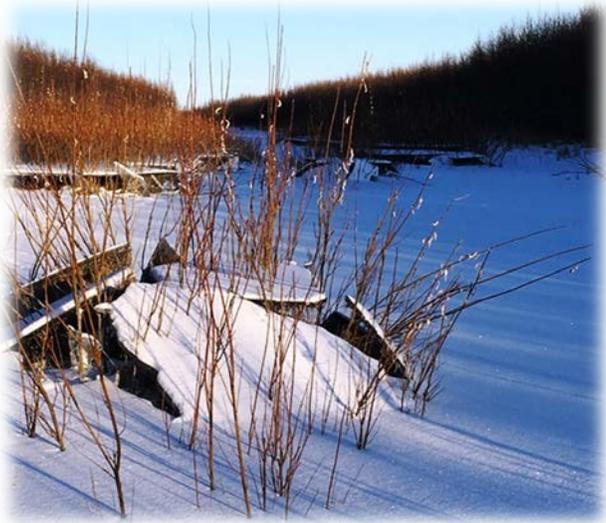
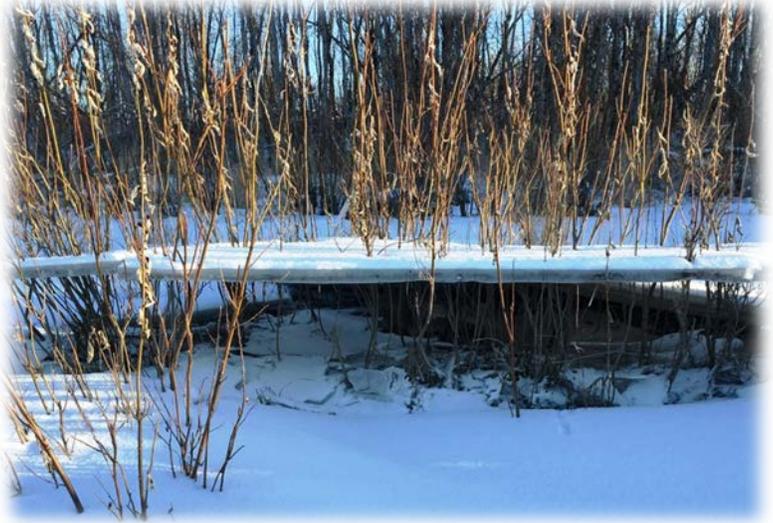
*Shell ice is present throughout the Lower Kuskokwim from the high water freeze up – these pictures show how much the water has dropped*

**BEWARE OF HOLLOW SOUNDING ICE AS YOU DRIVE OR WALK OVER IT**

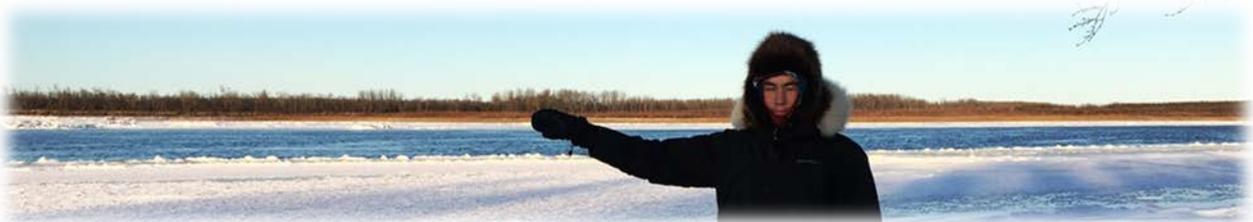
**We have to remember that it's only November and that there are still large areas of open water and thin ice**

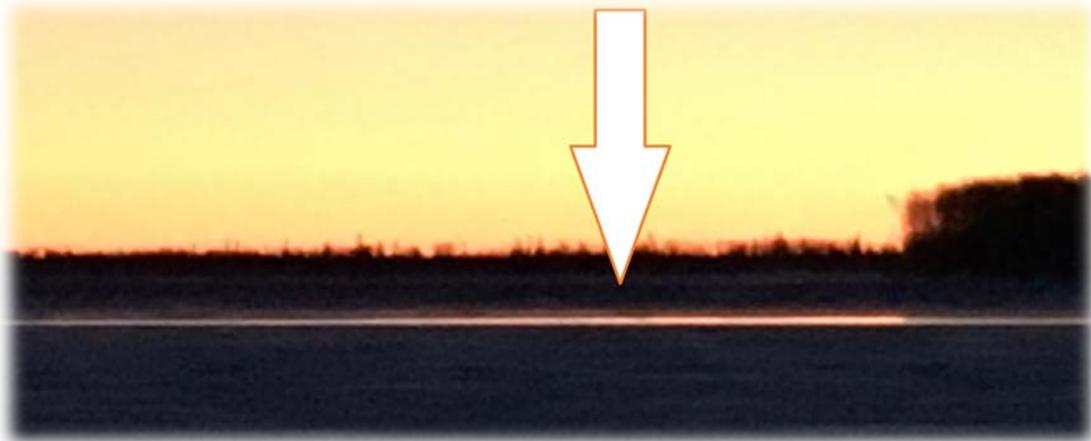
**The DANGER of unmarked open water in low light: If a traveler had his back to the sunset this open water would be very hard to see**

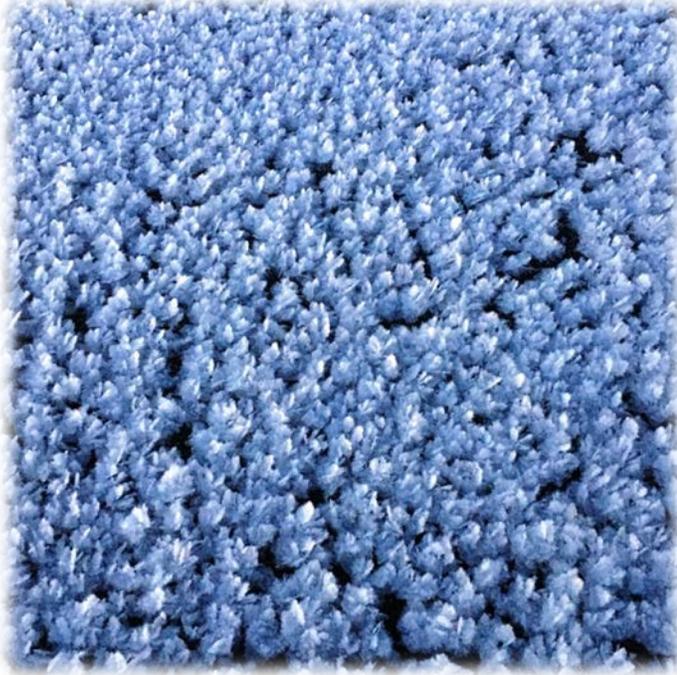
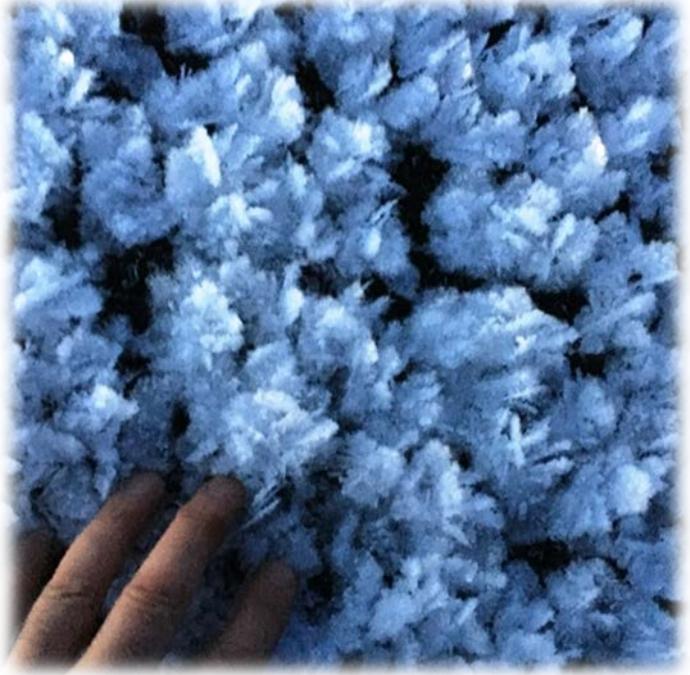
Ice Crystals form when warmer River water is close to the cold surface air. These large flowery crystals can be mistaken for snow cover. These pictures were taken below Akiak. The two big bends below Akiak only recently froze over and are only 6" thick all the way across.
